**Flood Control Project Maintenance
Levee Inspections**

2018 Channel Summary Report

DWR Sutter Maintenance Yard

Big Chico Creek

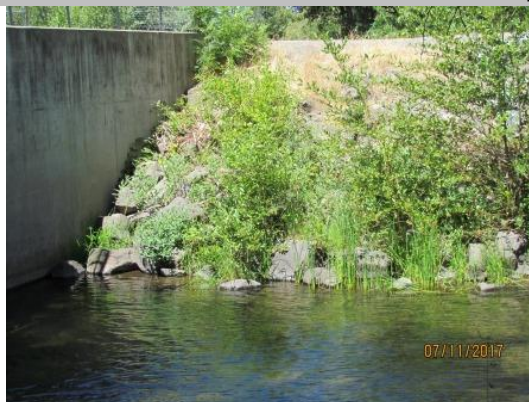
Photo 1 of 1 : CH_2018_NA0060_5_4_20180716_00002.jpg

Rating **	A	Issue No.	4	GPS Lat/Long
Issue Type +	Ma	Location *		39.761840 °
Category	Rivers, Channels & Designated Flood			-121.792590 °
Item	Revetments			
DWR ID	DWR_NA0060_5_c_2012_4			
Action/Comments				
Inspector Comments: Riprap is visible and appears properly maintained. Vegetation growth, especially trees, should be managed.

View of typical revetment on the upstream side of the structure, 2017.

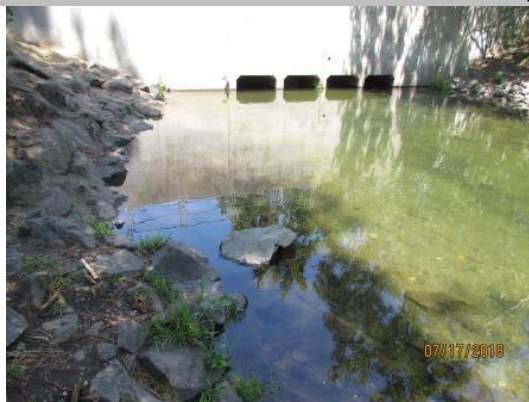
Photo 1 of 1 : CH_2018_NA0060_5_9_20180730_00029.jpg

Rating **	A	Issue No.	9	GPS Lat/Long
Issue Type +	Ma	Location *		39.761840 °
Category	Rivers, Channels & Designated Flood			-121.792590 °
Item	Revetments			
DWR ID	DWR_NA0060_5_c _ 2012_9			
Action/Comments				
Inspector Comments: Riprap is visible and appears properly maintained.

View of the downstream side of the channel from the structure, 2018.

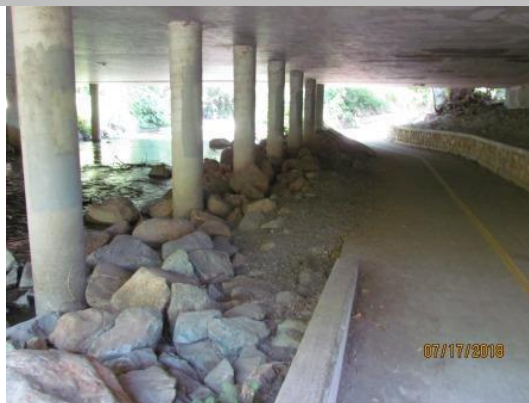
Photo 1 of 2 : CH_2018_NA0060_5_14_20180730_00036.jpg

Rating **	A	Issue No.	14	GPS Lat/Long
Issue Type +	Ma	Location *		39.758224 °
Category	Rivers, Channels & Designated Flood			-121.795853 °
Item	Revetments			
DWR ID	DWR_NA0060_5_c_2012_14			
Action/Comments				
Inspector Comments: Riprap is visible and appears properly maintained.

View looking upstream at the left bank of typical revetment around the abutment and bike path, 2018.

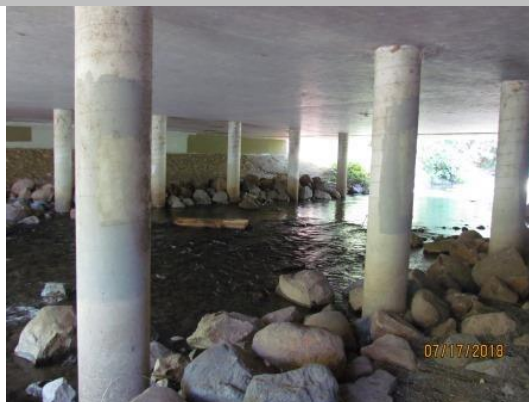
Photo 2 of 2 : CH_2018_NA0060_5_14_20180730_00035.jpg

Rating **	A	Issue No.	14 (cont)	GPS Lat/Long
Issue Type +	Ma	Location *		39.758224 °
Category	Rivers, Channels & Designated Flood			-121.795853 °
Item	Revetments			
DWR ID	DWR_NA0060_5_c_2012_14			
Action/Comments				
Inspector Comments: Riprap is visible and appears properly maintained.

View looking upstream at the right bank of typical revetment around the abutment and bike path, 2018.

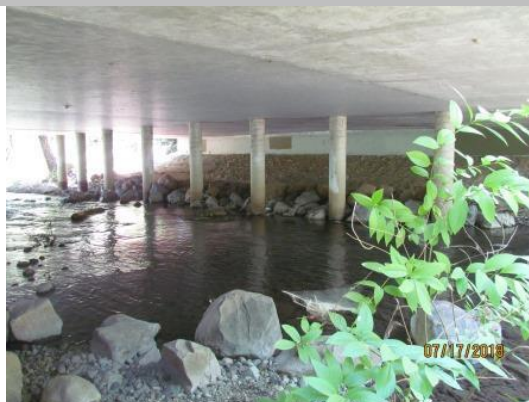
Photo 1 of 2 : CH_2018_NA0060_5_19_20180730_00038.jpg

Inspector Comments: Riprap is visible and appears properly maintained.

View looking downstream at the right bank of typical revetment around the abutment, 2018.

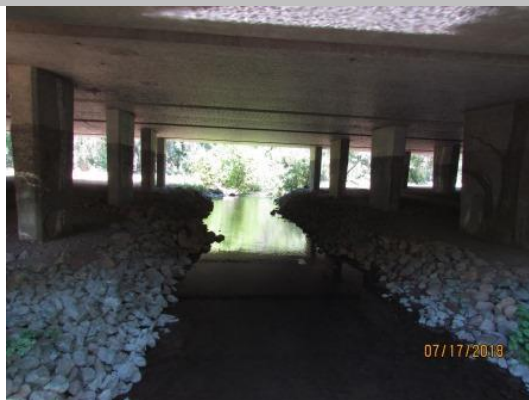
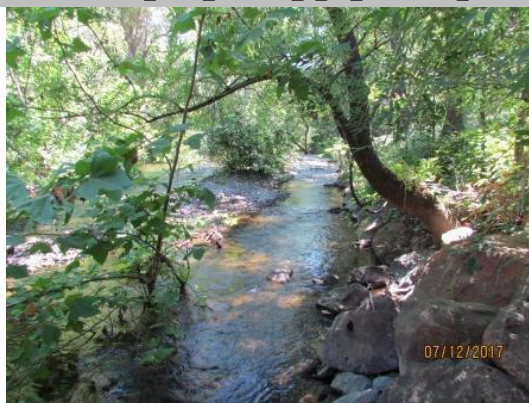
Rating **	A	Issue No.	21 (cont)	GPS Lat/Long
Issue Type +	Ma	Location *		39.738490 °
Category	Rivers, Channels & Designated Flood			-121.822810 °
Item	Vegetation & Obstructions			
DWR ID	DWR_NA0060_5_c_2012_21

View of the channel from under Highway 99 facing upstream, 2018.

View of the channel up from Highway 99 facing upstream, 2017.

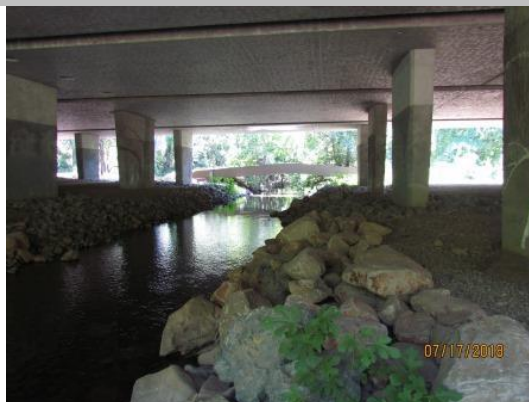
Photo 1 of 1 : CH_2018_NA0060_5_26_20180730_00042.jpg

Rating **	M	Issue No.	26	GPS Lat/Long
Issue Type +	Ma	Location *		39.738490 °
Category	Rivers, Channels & Designated Flood			-121.822810 °
Item	Vegetation & Obstructions			
DWR ID	DWR_NA0060_5_c_2012_26			
Action/Comments				
Inspector Comments: Scattered obstructions and vegetation, the flow is not impeded.

View of the channel under Highway 99 facing downstream, 2018.

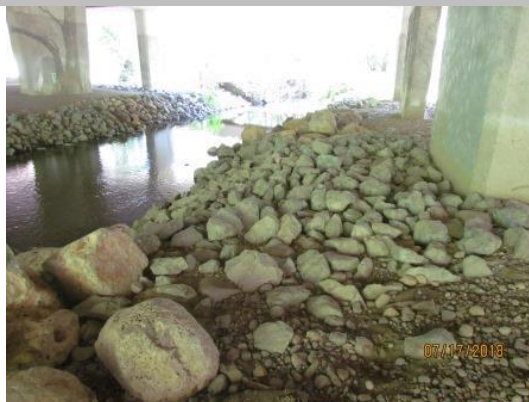
Photo 1 of 1 : CH_2018_NA0060_5_29_20180730_00043.jpg

Rating **	A	Issue No.	29	GPS Lat/Long
Issue Type +	Ma	Location *		39.738490 °
Category	Rivers, Channels & Designated Flood			-121.822810 °
Item	Revetments			
DWR ID	DWR_NA0060_5_c_2012_29			
Action/Comments				
Inspector Comments: Existing riprap protection is properly maintained and is undamaged. Riprap clearly visible.

View of the type of riprap that lines the channel, 2018.

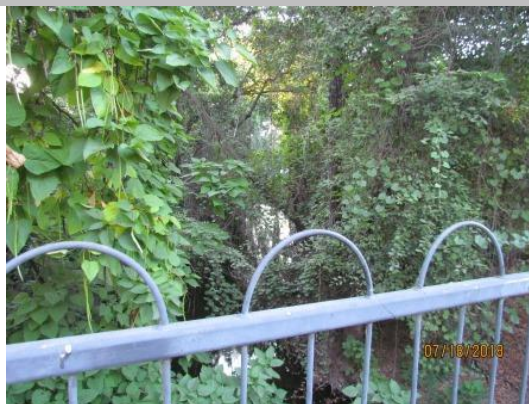
Photo 1 of 1 : CH_2018_NA0060_5_31_20180730_00045.jpg

Rating **	A	Issue No.	31	GPS Lat/Long
Issue Type +	Ma	Location *		39.731810 °
Category	Rivers, Channels & Designated Flood			-121.841870 °
Item	Vegetation & Obstructions			
DWR ID	DWR_NA0060_5_c_2012_31			
Action/Comments				
Inspector Comments: Scattered obstructions and vegetation is minimal. The flow is not impeded.

View of the channel facing upstream, 2018.

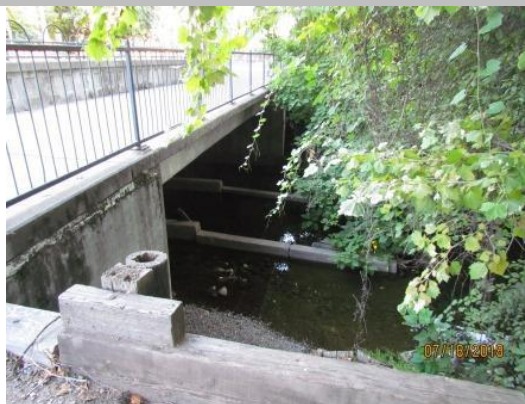
Photo 1 of 1 : CH_2018_NA0060_5_34_20180730_00046.jpg

Rating **	N	Issue No.	34	GPS Lat/Long
Issue Type +	Ma	Location *		39.731810 °
Category	Rivers, Channels & Designated Flood			-121.841870 °
Item	Revetments			
DWR ID	DWR_NA0060_5_c_2012_34			
Action/Comments				
Inspector Comments: No revetments present.

No visible revetment, 2108.

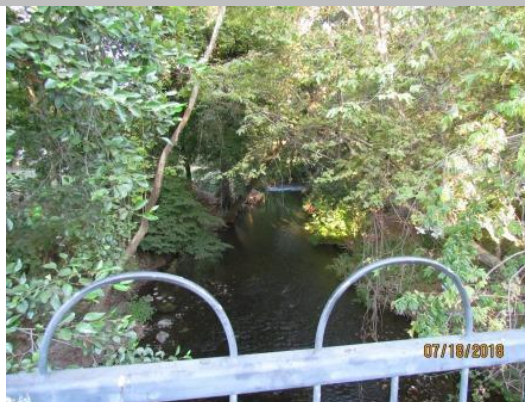
Photo 1 of 1 : CH_2018_NA0060_5_36_20180730_00047.jpg

Rating **	A	Issue No.	36	GPS Lat/Long
Issue Type +	Ma	Location *		39.731810 °
Category	Rivers, Channels & Designated Flood			-121.841870 °
Item	Vegetation & Obstructions			
DWR ID	DWR_NA0060_5_c_2012_36			
Action/Comments				
Inspector Comments: Scattered obstructions and vegetation. The flow is not impeded.

View from the bridge of the channel facing downstream, 2018.

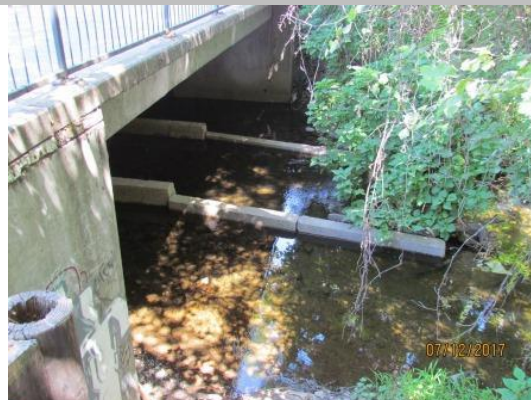
Photo 1 of 1 : CH_2018_NA0060_5_40_20180716_00018.jpg

Rating **	A	Issue No.	40	GPS Lat/Long
Issue Type +	Ma	Location *		39.731810 °
Category	Rivers, Channels & Designated Flood			-121.841870 °
Item	Encroachments			
DWR ID	DWR_NA0060_5_c _ 2012_40			
Action/Comments				
Inspector Comments: Old bridge footings are within the project easement area, flow is not impeded, 2017.

View of old bridge footing in the channel, 2017.

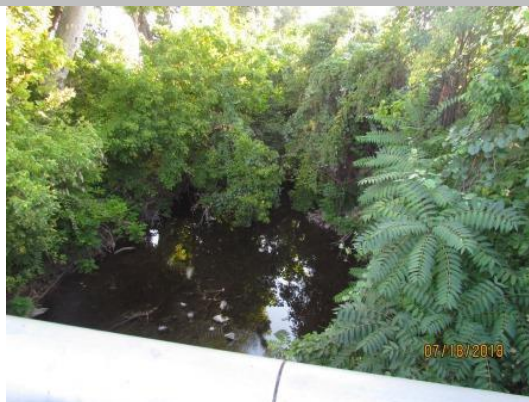
Photo 1 of 1 : CH_2018_NA0060_5_41_20180730_00049.jpg

Rating **	M	Issue No.	41	GPS Lat/Long
Issue Type +	Ma	Location *		39.725776 °
Category	Rivers, Channels & Designated Flood			-121.851207 °
Item	Vegetation & Obstructions			
DWR ID	DWR_NA0060_5_c_2012_41			
Action/Comments				
Inspector Comments: Scattered obstructions and vegetation. The flow is not impeded.

View of the channel facing upstream, 2108.

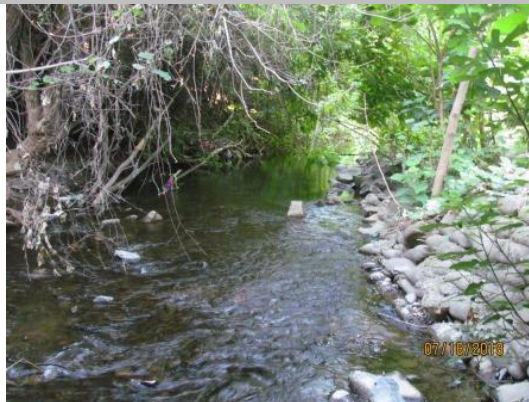
Photo 1 of 1 : CH_2018_NA0060_5_46_20180730_00054.jpg

Rating **	M	Issue No.	46	GPS Lat/Long
Issue Type +	Ma	Location *		39.725776 °
Category	Rivers, Channels & Designated Flood			-121.851207 °
Item	Vegetation & Obstructions			
DWR ID	DWR_NA0060_5_c_2012_46			
Action/Comments				
Inspector Comments: Moderate vegetation on north bank. The flow is not impeded.

View of the channel facing downstream, 2108.

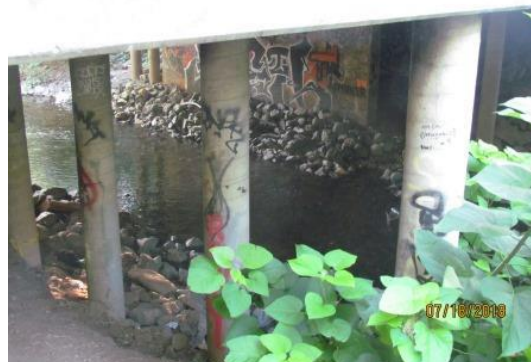
Photo 1 of 1 : CH_2018_NA0060_5_49_20180730_00052.jpg

Rating **	A	Issue No.	49	GPS Lat/Long
Issue Type +	Ma	Location *		39.725776 °
Category	Rivers, Channels & Designated Flood			-121.851207 °
Item	Revetments			
DWR ID	DWR_NA0060_5_c_2012_49			
Action/Comments				
Inspector Comments: Revetments present.

View of revetment around the bridge structure, 2018.

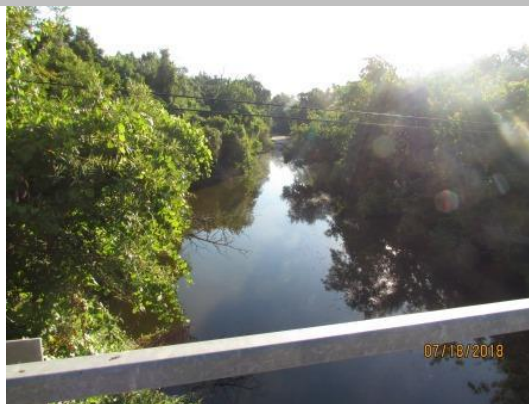
Photo 1 of 1 : CH_2018_NA0060_5_51_20180730_00053.jpg

Inspector Comments: Scattered obstructions and vegetation. The flow is not impeded.

View of Mud Creek at River Road facing upstream, 2018.

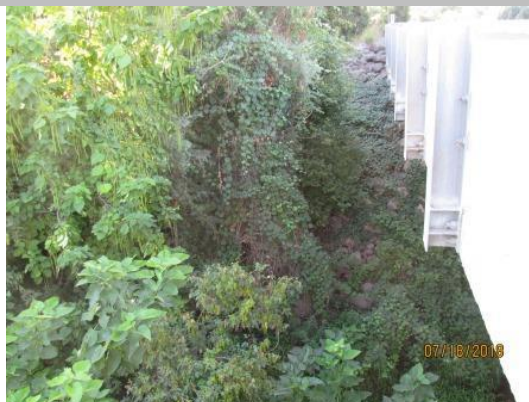
Photo 1 of 1 : CH_2018_NA0060_5_54_20180730_00056.jpg

Inspector Comments: Riprap is covered with vegetation. Trees and other vegetation growth should be managed/removed from riprap.

View of the revetment that is over grown with vegetation, 2018.

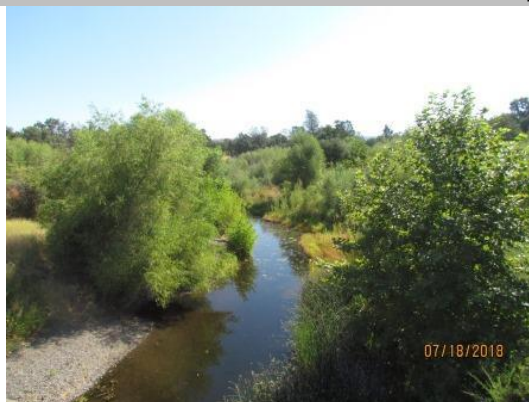
Photo 1 of 1 : CH_2018_NA0060_6_1_20180730_00051.jpg

Inspector Comments: Minimal, scattered obstructions and small trees. The flow is not impeded.

View of the channel facing upstream, 2018.

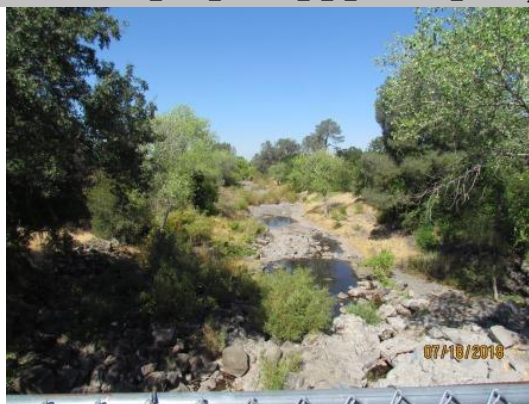
Photo 1 of 1 : CH_2018_NA0060_6_6_20180730_00052.jpg

Inspector Comments: Minimal, scattered obstructions or vegetation. The flow is not impeded.

View of the channel facing downstream, 2018.

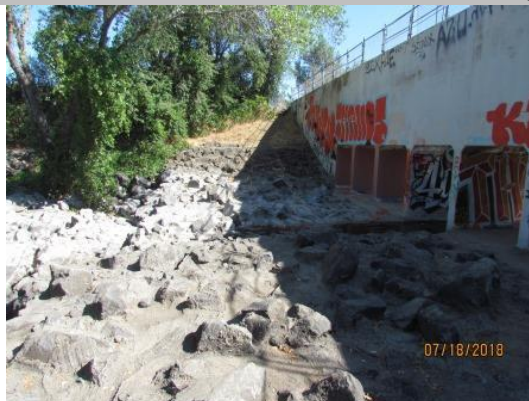
Photo 1 of 2 : CH_2018_NA0060_6_9_20180730_00053.jpg

Rating **	A	Issue No.	9	GPS Lat/Long
Issue Type +	Ma	Location *		39.761590 °
Category	Rivers, Channels & Designated Flood			-121.797320 °
Item	Revetments			
DWR ID	DWR_NA0060_6_c_2012_9			
Action/Comments				
Inspector Comments: Revetment is well maintained at this location.

View of revetment downstream of structure, right bank, 2018.

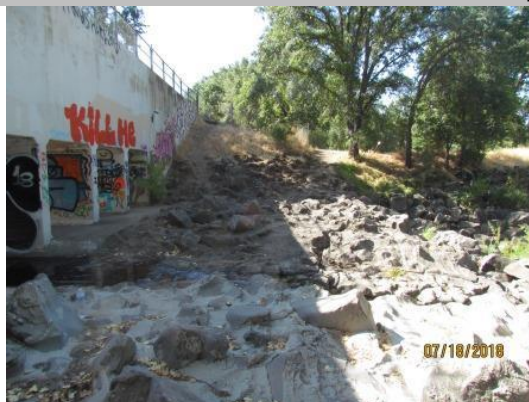
Photo 2 of 2 : CH_2018_NA0060_6_9_20180730_00054.jpg

Inspector Comments: Revetment is well maintained at this location.

View of revetment downstream of structure, left bank, 2018.

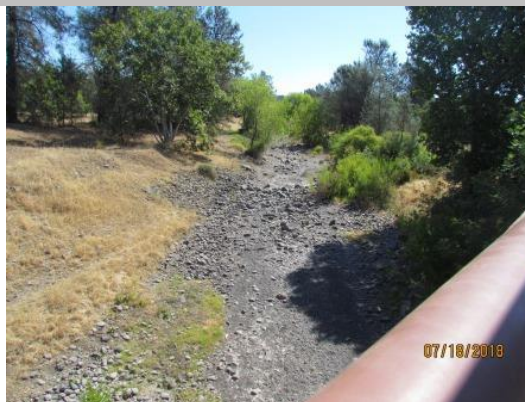
Photo 1 of 1 : CH_2018_NA0060_6_11_20180730_00055.jpg

Rating **	A	Issue No.	11	GPS Lat/Long
Issue Type +	Ma	Location *		39.760390 °
Category	Rivers, Channels & Designated Flood			-121.801621 °
Item	Vegetation & Obstructions			
DWR ID	DWR_NA0060_6_c _ 2012_11			
Action/Comments				
Inspector Comments: Minimal, scattered obstructions or vegetation. The flow is not impeded.

View of the channel facing upstream, 2018.

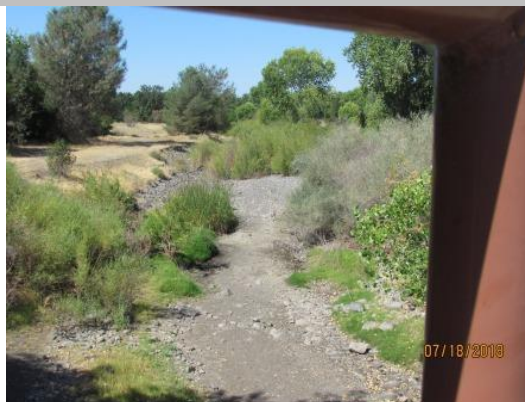
Photo 1 of 1 : CH_2018_NA0060_6_16_20180730_00057.jpg

Rating **	M	Issue No.	16	GPS Lat/Long
Issue Type +	Ma	Location *		39.760390 °
Category	Rivers, Channels & Designated Flood			-121.801621 °
Item	Vegetation & Obstructions			
DWR ID	DWR_NA0060_6_c_2012_16			
Action/Comments				
Inspector Comments: Minimal, scattered obstructions or vegetation. The flow is not impeded.

View of the channel facing downstream, 2018.

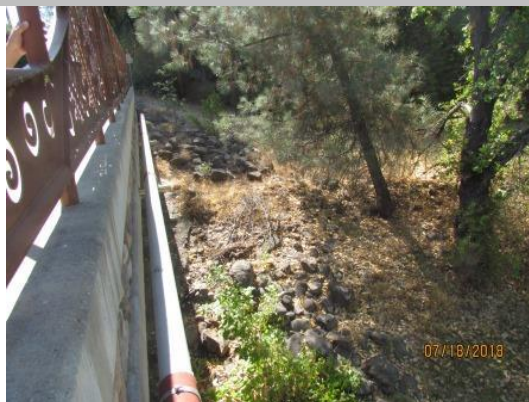
Photo 1 of 2 : CH_2018_NA0060_6_19_20180730_00058.jpg

Inspector Comments: Revetment at downstream side of the abutment.

View of revetment at downstream, left bank side of the abutment, 2018.

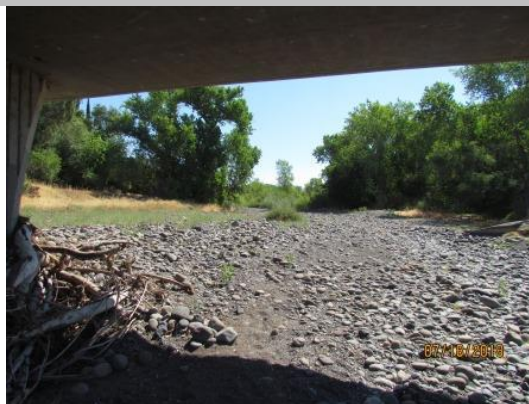
Photo 1 of 1 : CH_2018_NA0060_6_21_20180730_00060.jpg

Rating **	A	Issue No.	21	GPS Lat/Long
Issue Type +	Ma	Location *		39.755400 °
Category	Rivers, Channels & Designated Flood			-121.814580 °
Item	Vegetation & Obstructions			
DWR ID	DWR_NA0060_6_c_2012_21			
Action/Comments				
Inspector Comments: Minimal, scattered obstructions or vegetation. The flow is not impeded.

View of the channel facing upstream, 2018.

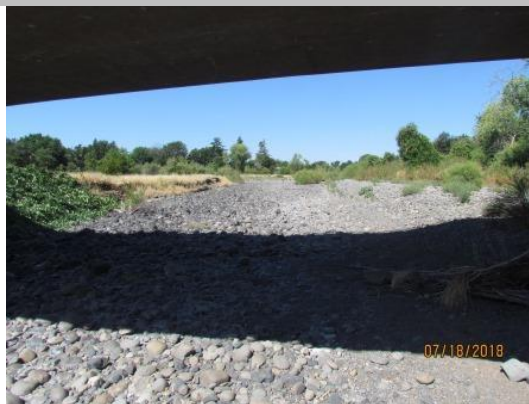
Photo 1 of 1 : CH_2018_NA0060_6_26_20180730_00067.jpg

Rating **	A	Issue No.	26	GPS Lat/Long
Issue Type +	Ma	Location *		39.755400 °
Category	Rivers, Channels & Designated Flood			-121.814580 °
Item	Vegetation & Obstructions			
DWR ID	DWR_NA0060_6_c_2012_26			
Action/Comments				
Inspector Comments: Minimal, scattered obstructions or vegetation. The flow is not impeded.

View of the channel facing downstream, 2018.

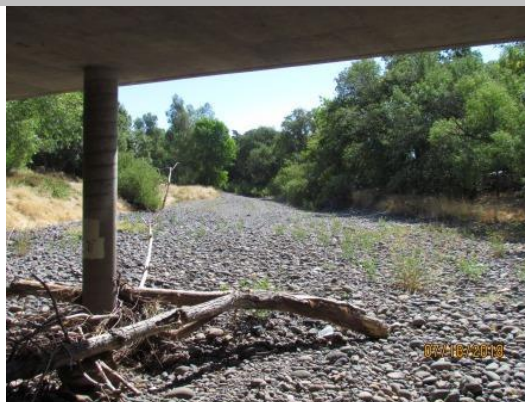
Photo 1 of 1 : CH_2018_NA0060_6_31_20180730_00069.jpg

Inspector Comments: Minimal, scattered log obstructions. The flow is not impeded.

View of the channel facing upstream from the bridge, 2018.

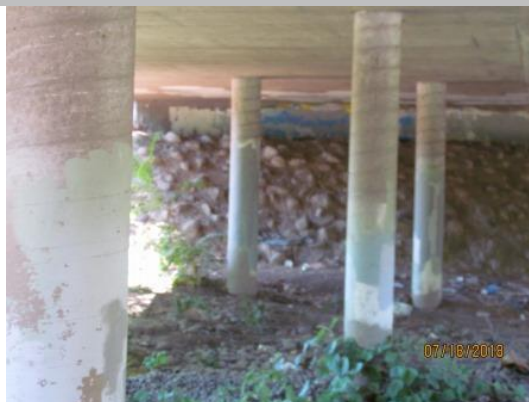
Photo 1 of 2 : CH_2018_NA0060_6_34_20180730_00070.jpg

Inspector Comments: Revetment on slope up to the bridge abutment, both sides.

View of left bank, revetment on slope up to the bridge abutment, 2017.

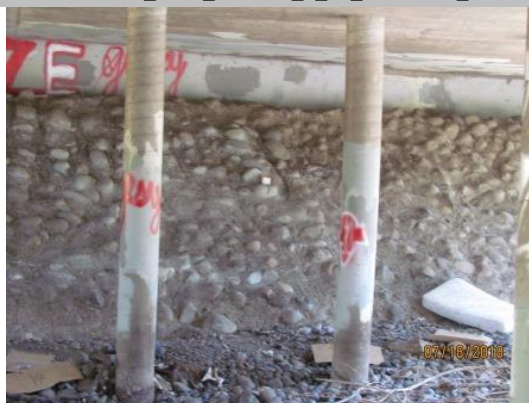
Photo 2 of 2 : CH_2018_NA0060_6_34_20180730_00071.jpg

View of right bank, revetment on slope up to the bridge abutment, 2017.

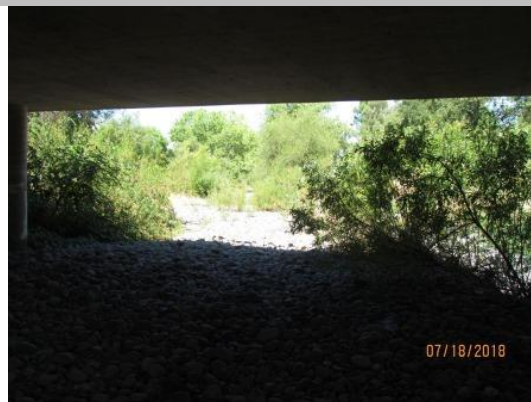
Photo 1 of 1 : CH_2018_NA0060_6_36_20180730_00072.jpg

Rating **	A	Issue No.	36	GPS Lat/Long
Issue Type +	Ma	Location *		39.752730 °
Category	Rivers, Channels & Designated Flood			-121.824560 °
Item	Vegetation & Obstructions			
DWR ID	DWR_NA0060_6_c_2012_36			
Action/Comments				
Inspector Comments: Minimal, scattered obstructions or vegetation. The flow is not impeded.

View of the channel facing downstream from the bridge, 2018.

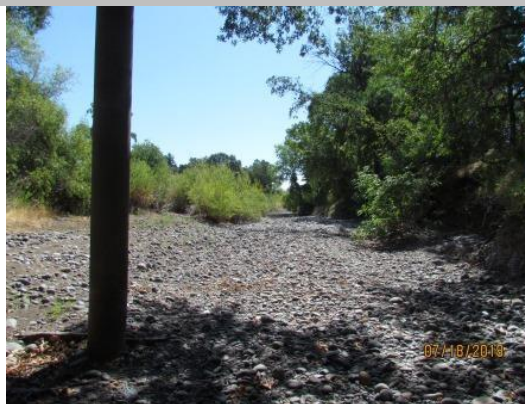
Photo 1 of 1 : CH_2018_NA0060_6_41_20180730_00073.jpg

Rating **	A	Issue No.	41	GPS Lat/Long
Issue Type +	Ma	Location *		39.753307 °
Category	Rivers, Channels & Designated Flood			-121.829234 °
Item	Vegetation & Obstructions			
DWR ID	DWR_NA0060_6_c _ 2012_41			
Action/Comments				
Inspector Comments: Minimal, scattered obstructions or vegetation. The flow is not impeded, 2018.

View of the channel facing upstream from under the bridge, 2018.

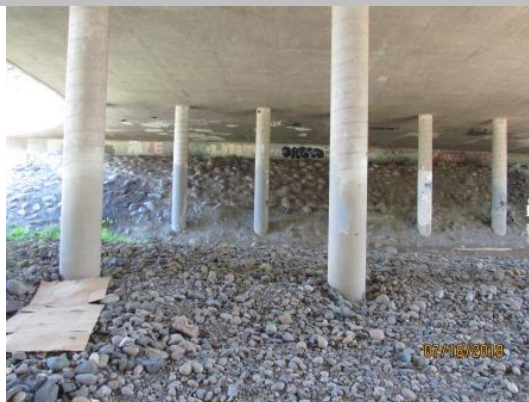
Photo 1 of 2 : CH_2018_NA0060_6_44_20180730_00075.jpg

Check Point / View				
5th Ave / Up (cont)				
Rating **	A	Issue No.	44	GPS Lat/Long
Issue Type +	Ma	Location *		39.753307°
Category	Rivers, Channels & Designated Flood			-121.829234°
Item	Revetments			
DWR ID	DWR_NA0060_6_c _ 2012_44			
Action/Comments				
Inspector Comments: Existing riprap protecting is properly maintained and is undamaged. Erosion at toe.

View of left bank, revetment on slope up to the bridge abutment, 2018.

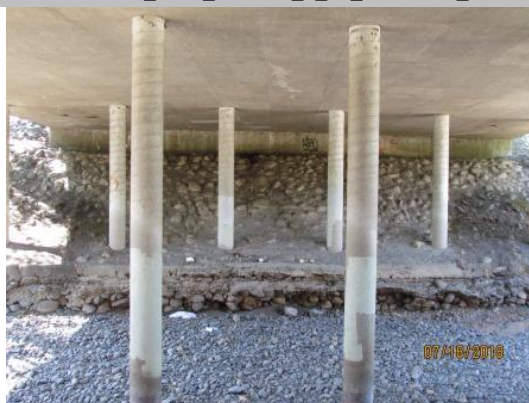
Photo 2 of 2 : CH_2018_NA0060_6_44_20180730_00076.jpg

View of right bank, revetment on slope up to the bridge abutment, 2018.

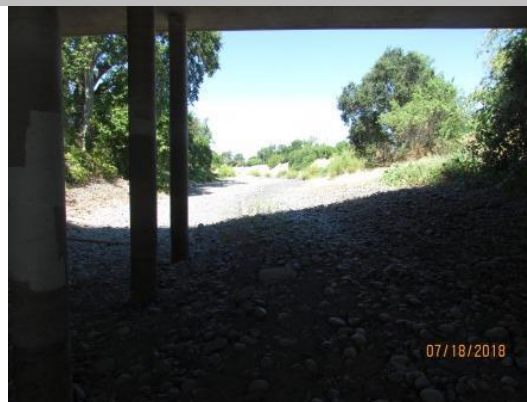
Photo 1 of 1 : CH_2018_NA0060_6_46_20180730_00077.jpg

Rating **	A	Issue No.	46	GPS Lat/Long
Issue Type +	Ma	Location *		39.753307 °
Category	Rivers, Channels & Designated Flood			-121.829234 °
Item	Vegetation & Obstructions			
DWR ID	DWR_NA0060_6_c_2012_46			
Action/Comments				
Inspector Comments: Minimal, scattered obstructions or vegetation. The flow is not impeded.

View of channel facing downstream from under the bridge, 2018.

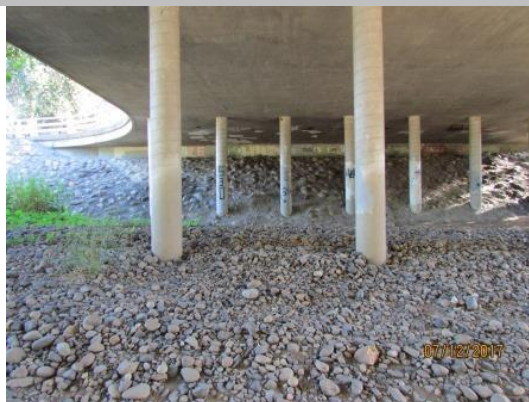
Photo 1 of 1 : CH_2018_NA0060_6_49_20180716_00023.jpg

Rating **	A	Issue No.	49	GPS Lat/Long
Issue Type +	Ma	Location *		39.753307 °
Category	Rivers, Channels & Designated Flood			-121.829234 °
Item	Revetments			
DWR ID	DWR_NA0060_6_c _ 2012_49			
Action/Comments				
Inspector Comments: Existing riprap protection is properly maintained and is undamaged. Riprap clearly visible.

View of left bank, revetment on slope up to the bridge abutment, 2017.

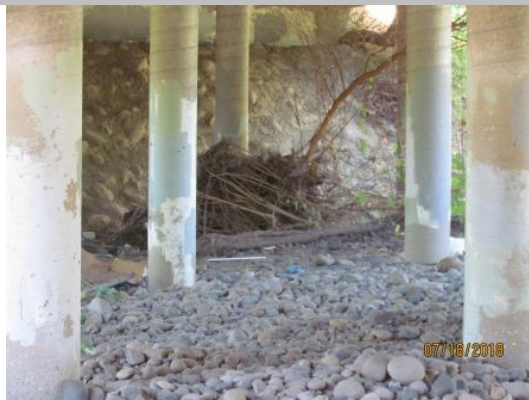
Photo 1 of 3 : CH_2018_NA0060_6_50_20180730_00080.jpg

Rating **	M	Issue No.	50	GPS Lat/Long
Issue Type +	Ma	Location *		39.753307 °
Category	Rivers, Channels & Designated Flood			-121.829234 °
Item	Encroachments			
DWR ID	DWR_NA0060_6_c _ 2012_50			
Action/Comments				
Inspector Comments: Trees, debris, and other obstructions present within the project easement area.

View of debris, limbs, and trees that have piled against the piers of the bridge, 2018.

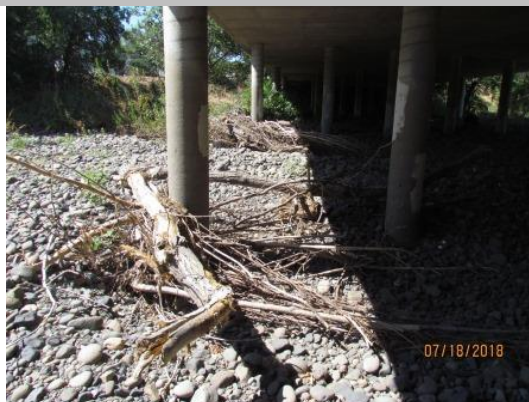
Photo 3 of 3 : CH_2018_NA0060_6_50_20180730_00078.jpg

View of debris, limbs, and trees that have piled against the piers of the bridge, 2018.

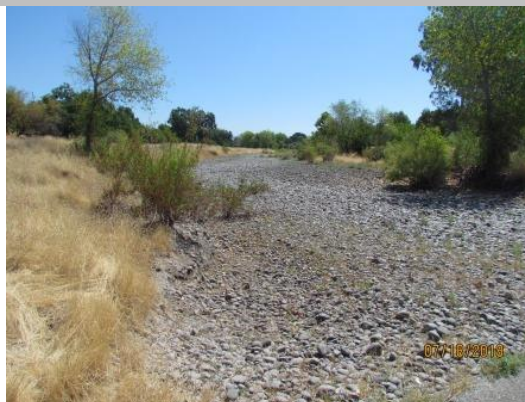
Photo 1 of 1 : CH_2018_NA0060_6_91_20180731_00081.jpg

Rating **	A	Issue No.	91	GPS Lat/Long
Issue Type +	Ma	Location *		39.751220 °
Category	Rivers, Channels & Designated Flood			-121.840042 °
Item	Vegetation & Obstructions			
DWR ID	DWR_NA0060_6_c_2015_91			
Action/Comments				
Inspector Comments: Minimal, scattered obstructions or vegetation. The flow is not impeded.

View of the channel facing upstream from the channel, 2018.

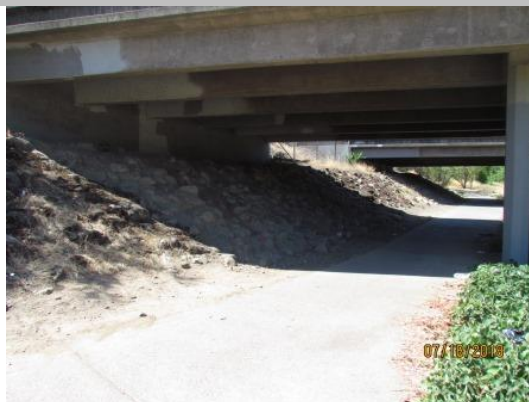
Photo 1 of 2 : CH_2018_NA0060_6_99_20180731_00083.jpg

Rating **	A	Issue No.	99	GPS Lat/Long
Issue Type +	Ma	Location *		39.751220 °
Category	Rivers, Channels & Designated Flood			-121.840042 °
Item	Revetments			
DWR ID	DWR_NA0060_6_c _ 2015_99			
Action/Comments				
Inspector Comments: Existing riprap protection is properly maintained and is undamaged. Riprap clearly visible.

View of left bank revetment looking upstream on slope up to the bridge abutment, 2018.

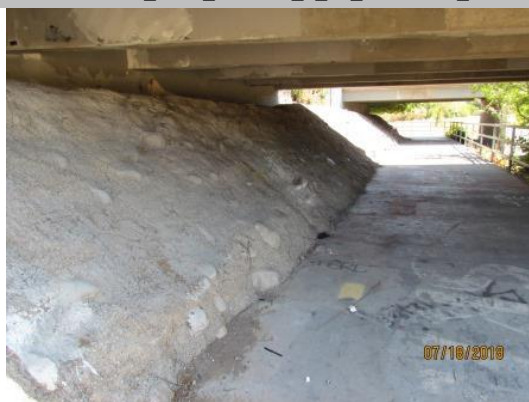
Photo 2 of 2 : CH_2018_NA0060_6_99_20180731_00084.jpg

View of right bank revetment looking upstream on slope up to the bridge abutment, 2018.

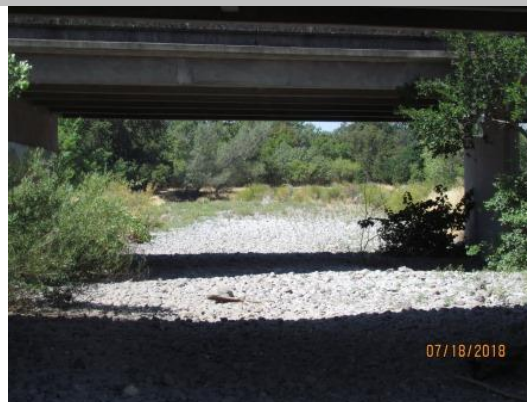
Photo 1 of 1 : CH_2018_NA0060_6_96_20180731_00082.jpg

Rating **	A	Issue No.	96	GPS Lat/Long
Issue Type +	Ma	Location *		39.751220 °
Category	Rivers, Channels & Designated Flood			-121.840042 °
Item	Vegetation & Obstructions			
DWR ID	DWR_NA0060_6_c_2015_96			
Action/Comments				
Inspector Comments: Minimal, scattered obstructions or vegetation. The flow is not impeded.

View of the channel facing downstream from under the north bound lanes of Highway 99, 2018.

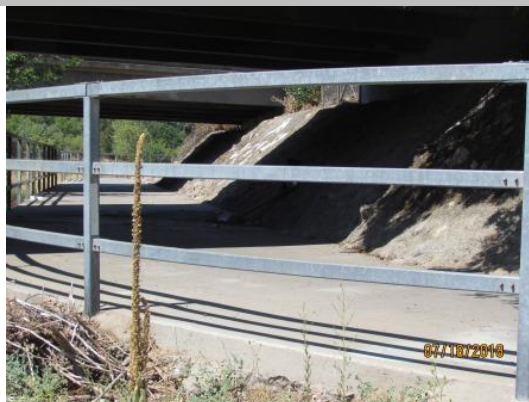
Photo 1 of 2 : CH_2018_NA0060_6_94_20180731_00085.jpg

Inspector Comments: Existing riprap protection is properly maintained and is undamaged. Riprap clearly visible.

Revetment on the right bank from the bike path to the abutment, looking downstream, 2018.

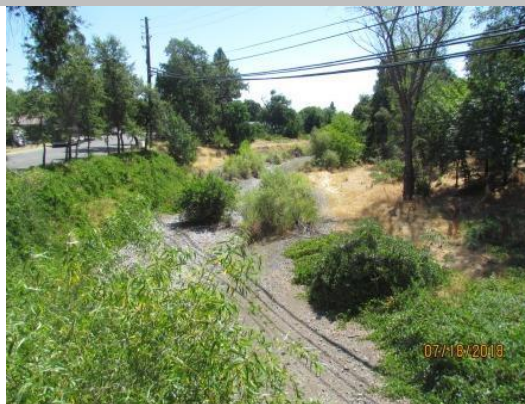
Photo 1 of 1 : CH_2018_NA0060_6_111_20180731_00087.jpg

Rating **	A	Issue No.	111	GPS Lat/Long
Issue Type +	Ma	Location *		39.750979 °
Category	Rivers, Channels & Designated Flood			-121.844711 °
Item	Vegetation & Obstructions			
DWR ID	DWR_NA0060_6_c _ 2015_111			
Action/Comments				
Inspector Comments: Minimal, scattered obstructions or vegetation. The flow is not impeded.

View of the channel looking upstream, 2018.

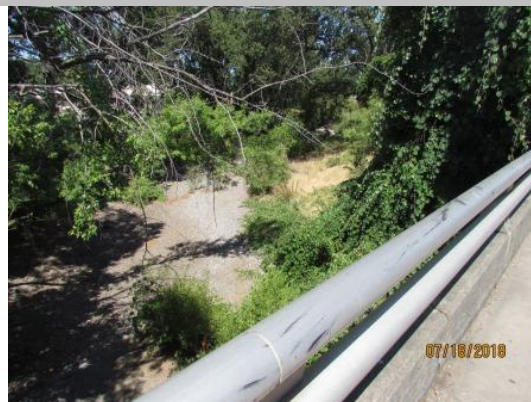
Photo 1 of 2 : CH_2018_NA0060_6_116_20180731_00092.jpg

Inspector Comments: Minimal, scattered obstructions and vegetation may impede the flow of the channel.

View of the channel facing downstream, 2018.

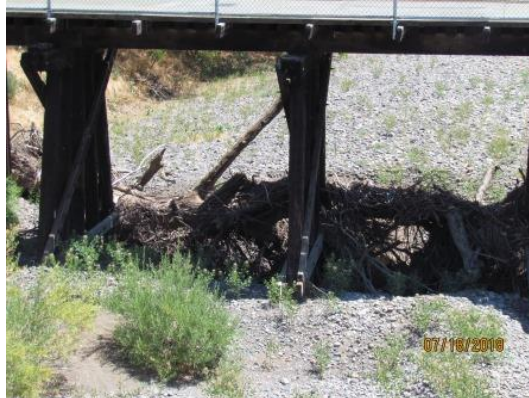
Photo 1 of 2 : CH_2018_NA0060_6_51_20180731_00095.jpg

Rating **	M	Issue No.	51	GPS Lat/Long
Issue Type +	Ma	Location *		39.749458 °
Category	Rivers, Channels & Designated Flood			-121.854296 °
Item	Vegetation & Obstructions			
DWR ID	DWR_NA0060_6_c _ 2012_51			
Action/Comments				
Inspector Comments: Minimal, scattered obstructions or vegetation. The flow is not impeded.

Closer view of debris caught in and around the foot bridge upstream, 2018.

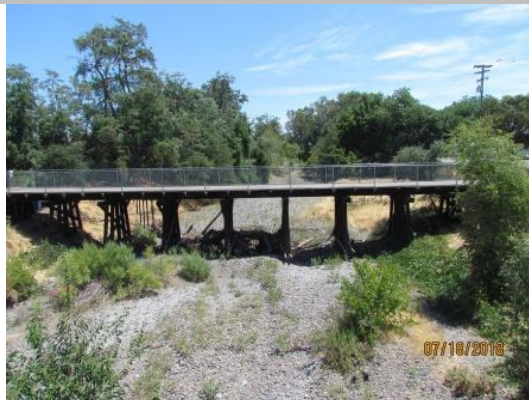
Photo 2 of 2 : CH_2018_NA0060_6_51_20180731_00094.jpg

View of the channel facing upstream. The debris that was caught on the foot bridge piles is no longer there, 2018.

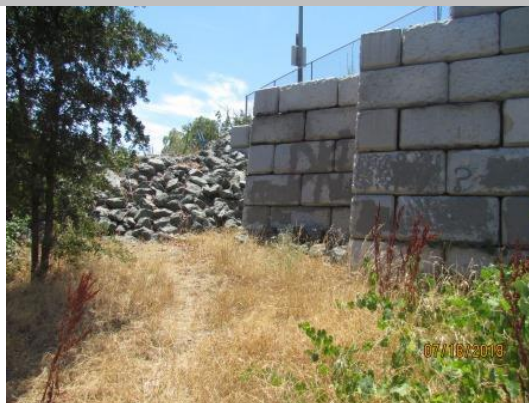
Photo 1 of 1 : CH_2018_NA0060_6_54_20180731_00096.jpg

Rating **	N	Issue No.	54	GPS Lat/Long
Issue Type +	Ma	Location *		39.749458 °
Category	Rivers, Channels & Designated Flood			-121.854296 °
Item	Revetments			
DWR ID	DWR_NA0060_6_c_2012_54			
Action/Comments				
Inspector Comments: This item does not apply to this inspection.

View of the left bank revetment next to the abutment, there is no revetment in the channel at the abutment, 2018.

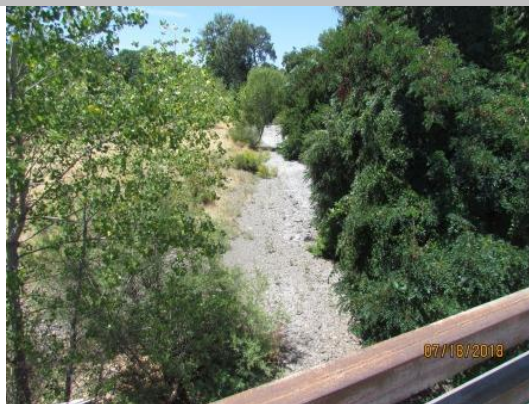
Photo 1 of 2 : CH_2018_NA0060_6_56_20180731_00098.jpg

Rating **	M	Issue No.	56	GPS Lat/Long
Issue Type +	Ma	Location *		39.749458 °
Category	Rivers, Channels & Designated Flood			-121.854296 °
Item	Vegetation & Obstructions			
DWR ID	DWR_NA0060_6_c _ 2012_56			
Action/Comments				
Inspector Comments: Vegetation & scattered obstructions. The flow may be impeded.

View of the channel facing downstream, 2018.

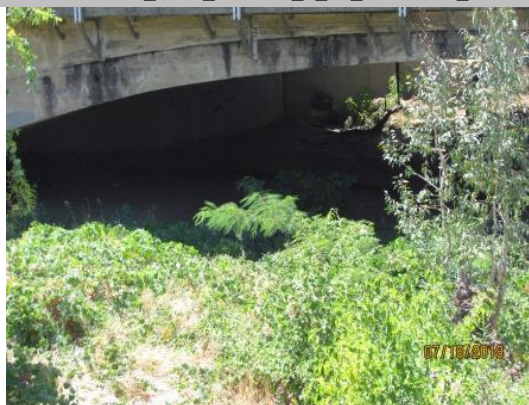
Photo 2 of 2 : CH_2018_NA0060_6_56_20180731_00100.jpg

View of the channel downstream side of the bridge, 2018.

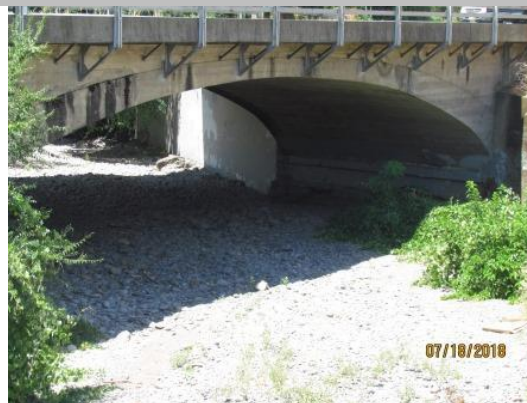
Photo 1 of 1 : CH_2018_NA0060_6_59_20180731_00097.jpg

Rating **	N	Issue No.	59	GPS Lat/Long
Issue Type +	Ma	Location *		39.749458°
Category	Rivers, Channels & Designated Flood			-121.854296°
Item	Revetments			
DWR ID	DWR_NA0060_6_c_2012_59			
Action/Comments				
Inspector Comments: There is no revetment in the channel at the abutment.

View of the right bank looking downstream, there is no revetment in the channel at the abutment, 2018.

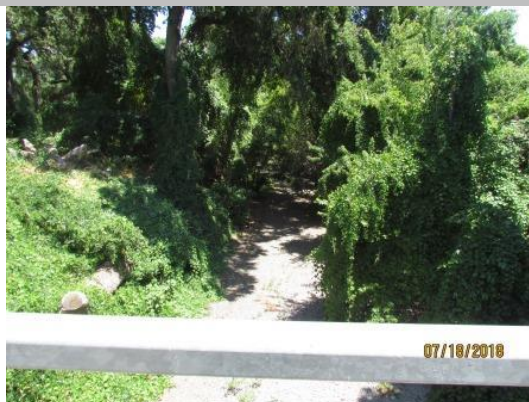
Photo 1 of 1 : CH_2018_NA0060_6_101_20180731_00101.jpg

Rating **	A	Issue No.	101	GPS Lat/Long
Issue Type +	Ma	Location *		39.749209 °
Category	Rivers, Channels & Designated Flood			-121.865682 °
Item	Vegetation & Obstructions			
DWR ID	DWR_NA0060_12_c_2015_101			
Action/Comments				
Inspector Comments: Minimal, scattered obstructions and vegetation. The flow does not look to be impeded.

View of the channel looking upstream, 2018.

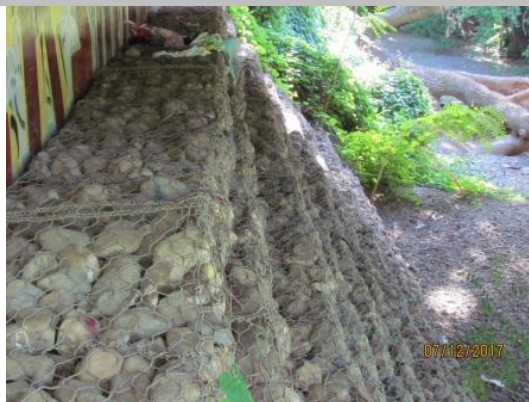
Photo 1 of 1 : CH_2018_NA0060_6_104_20180716_00044.jpg

Inspector Comments: Gabion wall revetment at bridge abutment, right bank.

View of gabion wall revetment at bridge abutment, right bank, 2017.

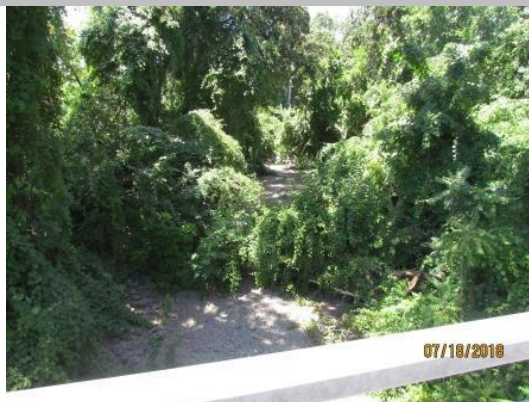
Photo 1 of 1 : CH_2018_NA0060_6_106_20180731_00104.jpg

Rating **	M	Issue No.	106	GPS Lat/Long
Issue Type +	Ma	Location *		39.749209 °
Category	Rivers, Channels & Designated Flood			-121.865682 °
Item	Vegetation & Obstructions			
DWR ID	DWR_NA0060_6_c_2015_106			
Action/Comments				
Inspector Comments: Minimal, scattered obstructions or vegetation. The flow may be impeded.

View of the channel looking downstream, 2018.

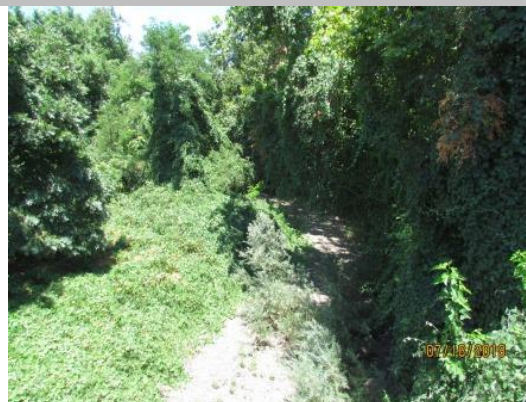
Photo 1 of 1 : CH_2018_NA0060_6_61_20180731_00105.jpg

Rating **	M	Issue No.	61	GPS Lat/Long
Issue Type +	Ma	Location *		39.741277 °
Category	Rivers, Channels & Designated Flood			-121.881402 °
Item	Vegetation & Obstructions			
DWR ID	DWR_NA0060_6_c_2012_61			
Action/Comments				
Inspector Comments: Vegetation exists and may impede the flow.

View of the channel looking upstream, 2018.

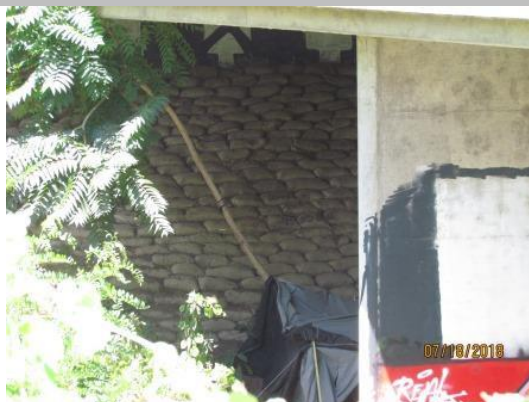
Photo 1 of 1 : CH_2018_NA0060_6_64_20180731_00106.jpg

Rating **	A	Issue No.	64	GPS Lat/Long
Issue Type +	Ma	Location *		39.741277 °
Category	Rivers, Channels & Designated Flood			-121.881402 °
Item	Revetments			
DWR ID	DWR_NA0060_6_c_2012_64			
Action/Comments				
Inspector Comments: Revetment is present but due to vegetation not all of it is visible.

View of concrete filled sandbag revetment, typical for both sides, 2018.

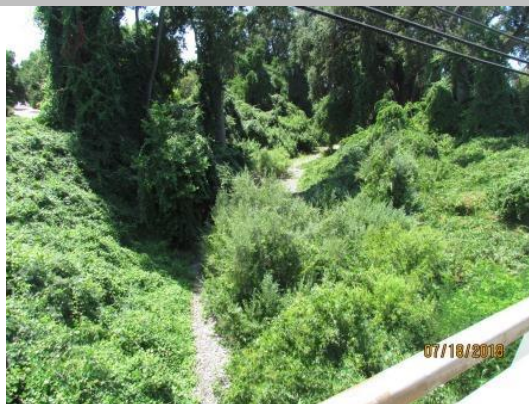
Photo 1 of 1 : CH_2018_NA0060_6_66_20180731_00107.jpg

Rating **	M	Issue No.	66	GPS Lat/Long
Issue Type +	Ma	Location *		39.741277 °
Category	Rivers, Channels & Designated Flood			-121.881402 °
Item	Vegetation & Obstructions			
DWR ID	DWR_NA0060_6_c_2012_66			
Action/Comments				
Inspector Comments: Vegetation exists and may impede the flow.

View of the channel looking downstream, 2018.

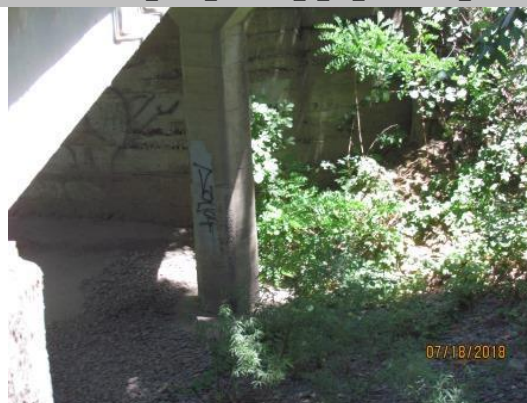
Photo 1 of 4 : CH_2018_NA0060_6_75_20180731_00109.jpg

Rating **	A	Issue No.	75	GPS Lat/Long
Issue Type +	Ma	Location *		39.735560 °
Category	Rivers, Channels & Designated Flood			-121.890970 °
Item	Encroachments			
DWR ID	DWR_NA0060_6_c_2012_75			
Action/Comments				
Inspector Comments: The large tree that was under the bridge in 2017 is no longer there, 2018.

View of where the trees from 2017 were lodged under the bridge, they no longer exist, 2018.

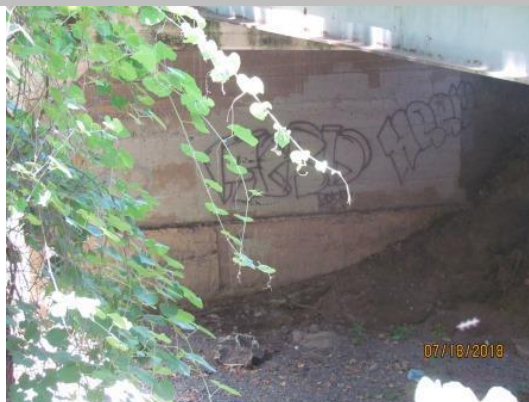
Photo 2 of 4 : CH_2018_NA0060_6_75_20180731_00110.jpg

Rating **	A	Issue No.	75 (cont)	GPS Lat/Long
Issue Type +	Ma	Location *		39.735560 °
Category	Rivers, Channels & Designated Flood			-121.890970 °
Item	Encroachments			
DWR ID	DWR_NA0060_6_c_2012_75			
Action/Comments				
Inspector Comments: The large tree that was under the bridge in 2017 is no longer there, 2018.

View of where the trees from 2017 were lodged under the bridge, they no longer exist, 2018.

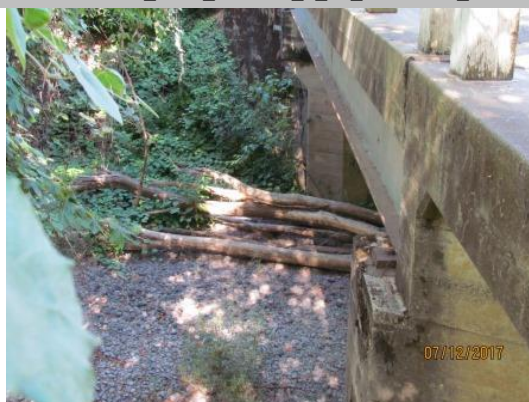
Photo 3 of 4 : CH_2018_NA0060_6_75_20180716_00032.jpg

View of a large tree that has washed down under the bridge on the right bank, 2017.

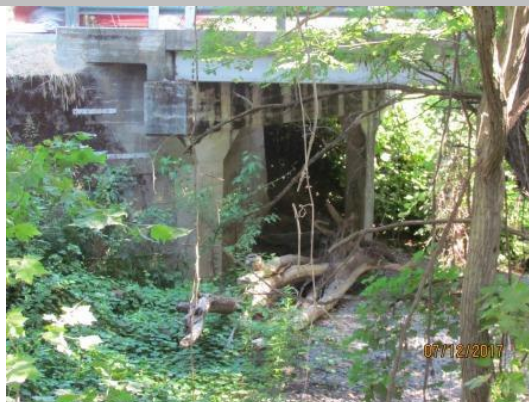
Photo 4 of 4 : CH_2018_NA0060_6_75_20180716_00033.jpg

Check Point / View				
Oak Ave. / Up (cont)				
Rating **	A	Issue No.	75 (cont)	GPS Lat/Long
Issue Type +	Ma	Location *		39.735560 °
Category	Rivers, Channels & Designated Flood			-121.890970 °
Item	Encroachments			
DWR ID	DWR_NA0060_6_c_2012_75			
Action/Comments				
Inspector Comments: The large tree that was under the bridge in 2017 is no longer there, 2018.

View of the same large tree that has washed down under the bridge on the right bank, 2017.

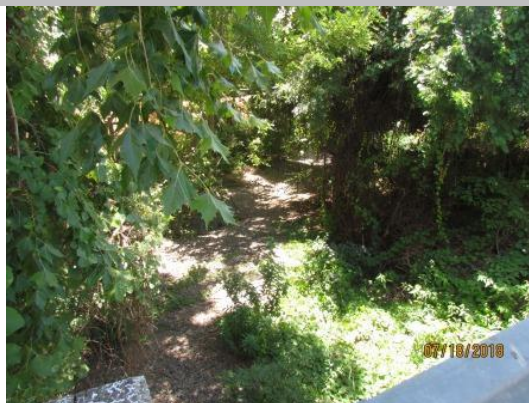
Photo 1 of 1 : CH_2018_NA0060_6_71_20180731_00111.jpg

Check Point / View				
Oak Ave. / Down				
Rating **	M	Issue No.	71	GPS Lat/Long
Issue Type +	Ma	Location *		39.735560 °
Category	Rivers, Channels & Designated Flood			-121.890970 °
Item	Vegetation & Obstructions			
DWR ID	DWR_NA0060_6_c_2012_71			
Action/Comments				
Inspector Comments: Scattered obstructions and vegetation, and may impede the flow of the channel.

View of the channel facing downstream, 2018.

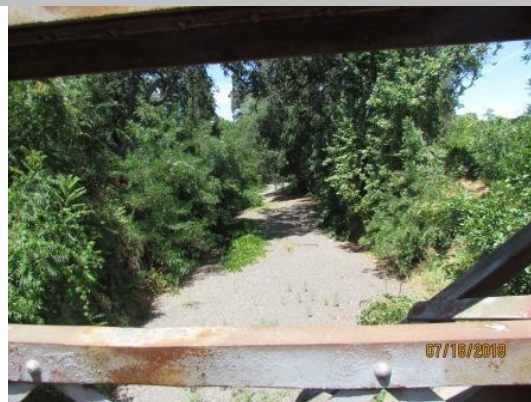
Photo 1 of 1 : CH_2018_NA0060_6_81_20180731_00112.jpg

Inspector Comments: Scattered obstructions and vegetation, flows not impeded in the channel.

View of the channel facing upstream, 2018.

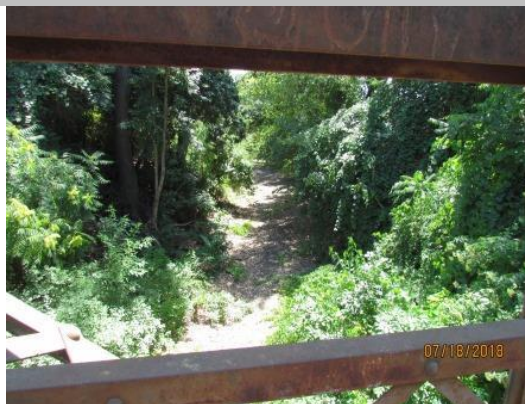
Photo 1 of 1 : CH_2018_NA0060_6_86_20180731_00114.jpg

Rating **	A	Issue No.	86	GPS Lat/Long
Issue Type +	Ma	Location *		39.722724 °
Category	Rivers, Channels & Designated Flood			-121.912363 °
Item	Vegetation & Obstructions			
DWR ID	DWR_NA0060_6_c_2012_86			
Action/Comments				
Inspector Comments: Scattered obstructions and vegetation, flows not impeded in the channel.

View of the channel facing downstream, 2018.

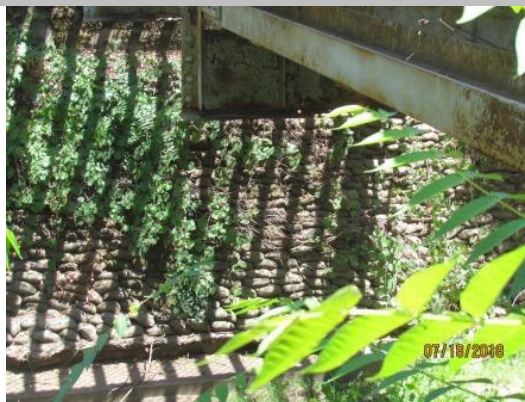
Photo 1 of 1 : CH_2018_NA0060_6_89_20180731_00113.jpg

Rating **	A	Issue No.	89	GPS Lat/Long
Issue Type +	Ma	Location *		39.722724 °
Category	Rivers, Channels & Designated Flood			-121.912363 °
Item	Revetments			
DWR ID	DWR_NA0060_6_c _ 2012_89			
Action/Comments				
Inspector Comments: Revetments are in place and maintained properly. Concrete sandbag revetment at bridge abutments, both sides.

View of concrete sandbag revetment at bridge abutments, 2018.

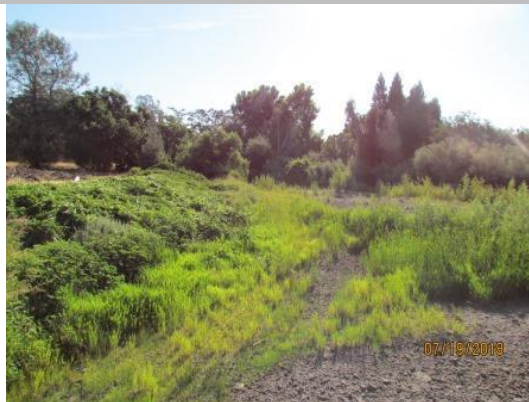
Photo 1 of 1 : CH_2018_NA0060_12_1_20180731_00043.jpg

Rating **	A	Issue No.	1	GPS Lat/Long
Issue Type +	Ma	Location *		39.733681 °
Category	Rivers, Channels & Designated Flood			-121.771865 °
Item	Vegetation & Obstructions			
DWR ID	DWR_NA0060_12_c_2012_1			
Action/Comments				
Inspector Comments: Minimal, scattered obstructions and vegetation. The flow is not impeded.

This is the upstream view from the Little Chico Control Structure, 2018.

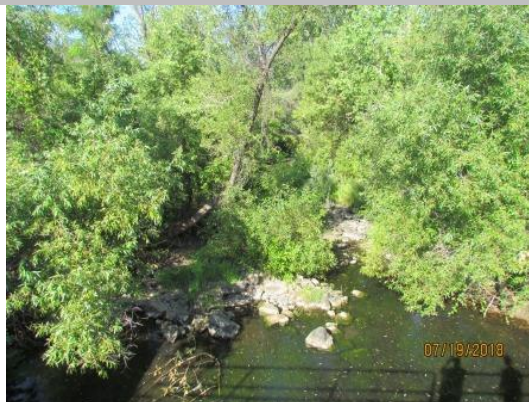
Photo 1 of 1 : CH_2018_NA0060_12_6_20180731_00044.jpg

Inspector Comments: Scattered obstructions and vegetation. The flow may be impeded. Willow trees should be removed.

This is the downstream view from the Little Chico Control Structure, 2018.

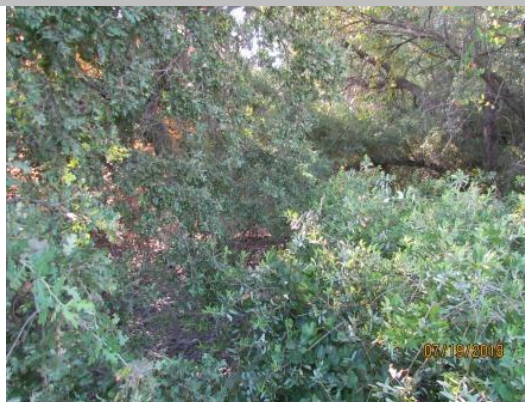
Photo 1 of 1 : CH_2018_NA0060_12_11_20180731_00045.jpg

Inspector Comments: The vegetation obstructed the view of the channel. Flow may be impeded in a high water event.

Photo of the channel facing upstream, 2018.

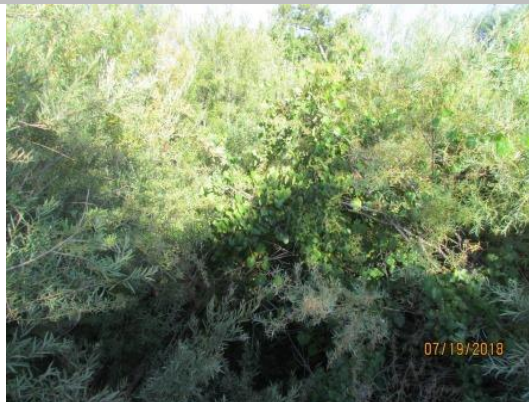
Photo 1 of 1 : CH_2018_NA0060_12_16_20180731_00046.jpg

Rating **	U	Issue No.	16	GPS Lat/Long
Issue Type +	Ma	Location *		39.733316 °
Category	Rivers, Channels & Designated Flood			-121.787540 °
Item	Vegetation & Obstructions			
DWR ID	DWR_NA0060_12_c_2012_16			
Action/Comments				
Inspector Comments: The vegetation obstructed the view of the channel. Flow may be impeded in a high water event.

Photo of the channel from the bridge facing downstream, 2018.

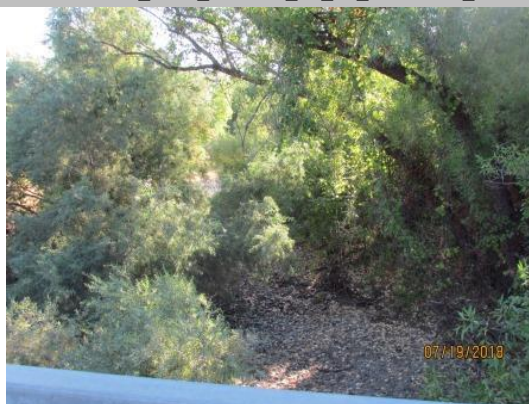
Photo 1 of 1 : CH_2018_NA0060_12_21_20180731_00047.jpg

Inspector Comments: Scattered obstructions and vegetation, and may impede the flow of the channel.

View of the channel from the bridge facing upstream, 2018.

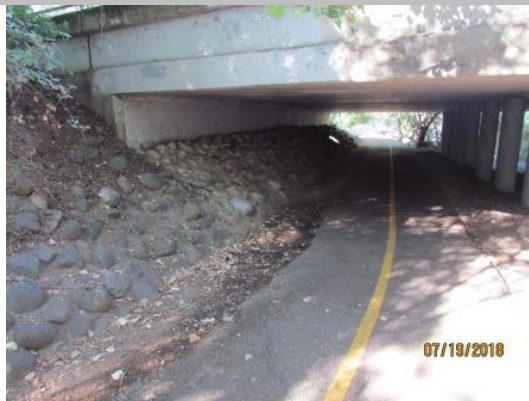
Photo 1 of 1 : CH_2018_NA0060_12_24_20180731_00048.jpg

Inspector Comments: Revetments present.

View of revetment on left bank, 2018.

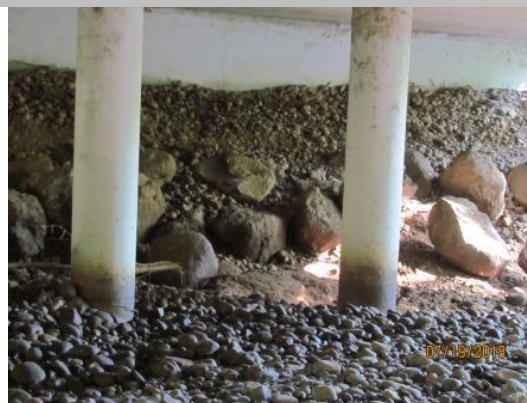
Photo 1 of 1 : CH_2018_NA0060_12_29_20180731_00050.jpg

Rating **	A	Issue No.	29	GPS Lat/Long
Issue Type +	Ma	Location *		39.737400 °
Category	Rivers, Channels & Designated Flood			-121.804530 °
Item	Revetments			
DWR ID	DWR_NA0060_12_c_2012_29			
Action/Comments				
Inspector Comments: Revetments present.

View of revetment on right bank, 2018.

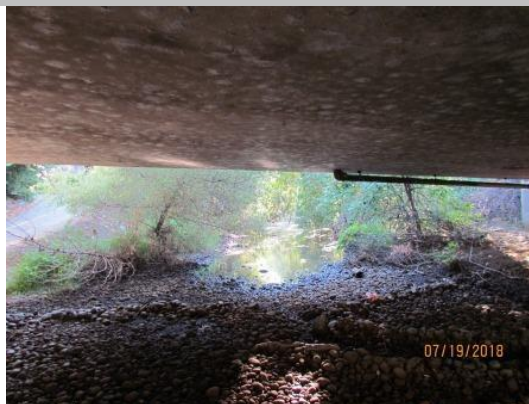
Photo 1 of 2 : CH_2018_NA0060_12_31_20180731_00052.jpg

Inspector Comments: Scattered vegetation. The flow does not appear impeded.

View looking upstream from Hwy 99 bridge, 2018.
